# Examination of the Home Destruction in Los Alamos Associated with the Cerro Grande Fire July 10, 2000

Jack D. Cohen  
Research Physical Scientist  
USDA Forest Service,  
Rocky Mountain Research Station  
Fire Sciences Laboratory  
Missoula, Montana

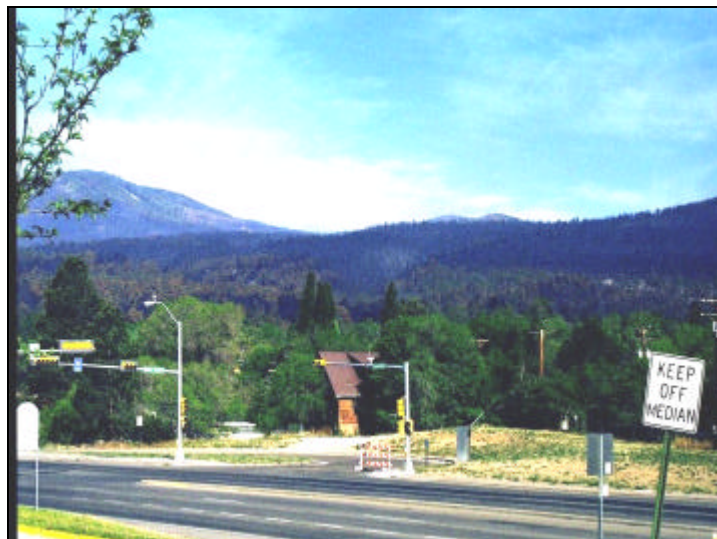
*Photo 1—The crown fire burned on the ridge (mid-picture) west of Los Alamos.*

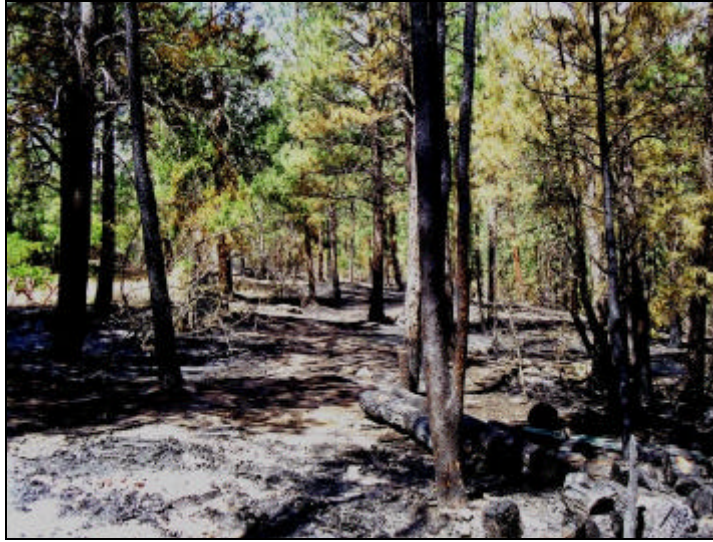
*Photo 2—The fire burned only in surface fuels as it came from the wild land in the background toward the residential area. The wild land fire commonly burned through continuous fuels to encounter and burn through heavier residential fuels such as woodpiles (bottom right), flammable shrubs, heavy pine needle beds, and homes.*

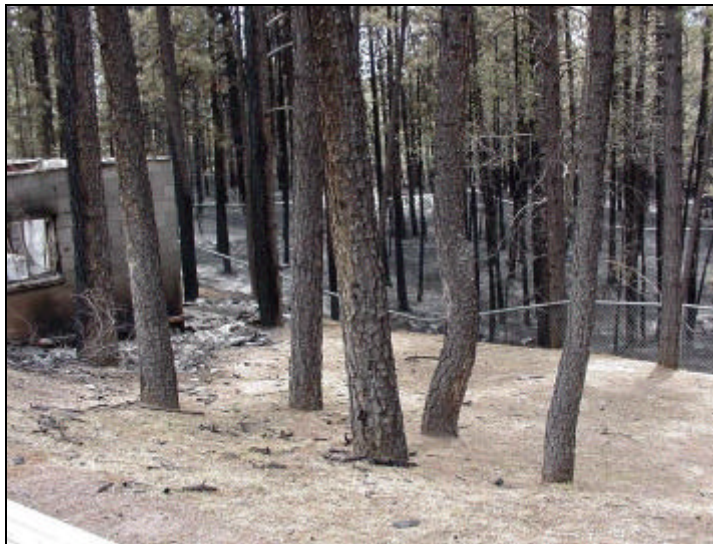
*Photo 3—Within the residential area, separated by several streets from the wild land, the fire generally burned as an under-burn with scorched but unconsumed tree canopies. The surface under the trees in the foreground did not burn, but the house to the left was totally destroyed.*

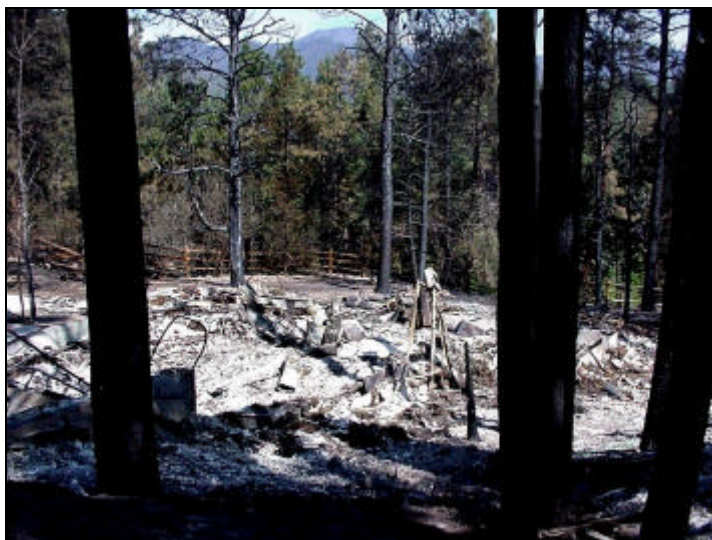
*Photo 4—The unconsumed, moderately scorched tree canopy along with the remaining wood rail fence indicate that this home was exposed to a low intensity surface fire. The high intensity wildfire burned on the hills in the background.*

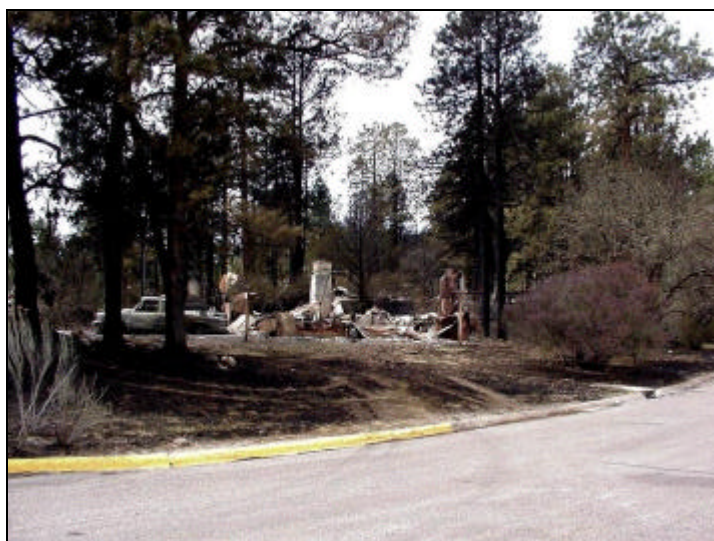
*Photo 5—This totally destroyed home was within the residential area. A road separated it from other burning vegetation and homes. The unconsumed vegetation with little scorch indicates that the fire intensity surrounding the home was low. This suggests that firebrands (burning embers from other fires) ignited the home directly and/or in adjacent flammable materials that spread to the home.*

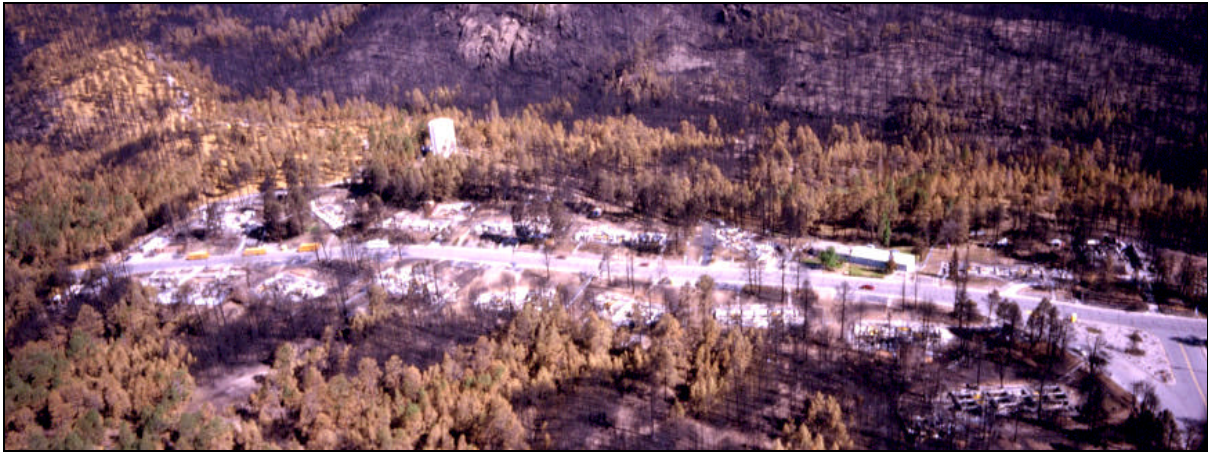
the 4-plexes on the northwest side (*Photo 6*), occurred from structure-to-structure spread (communication with Steve Coburn, LAFD). In general, the intense wildfire burned past the residential area to the west and north of Los Alamos. Scattered islands of destroyed homes at the community margin suggest low firebrand exposures and low spotting potential during the late night and morning hours during which much of the residential area burned.

*Photo 6—Significant structure-to-structure fire spread occurred from flames and firebrands in an area of multifamily residences. The unconsumed vegetation surrounding the corridor of destruction indicates that the high fire intensities were due to the burning structures.*

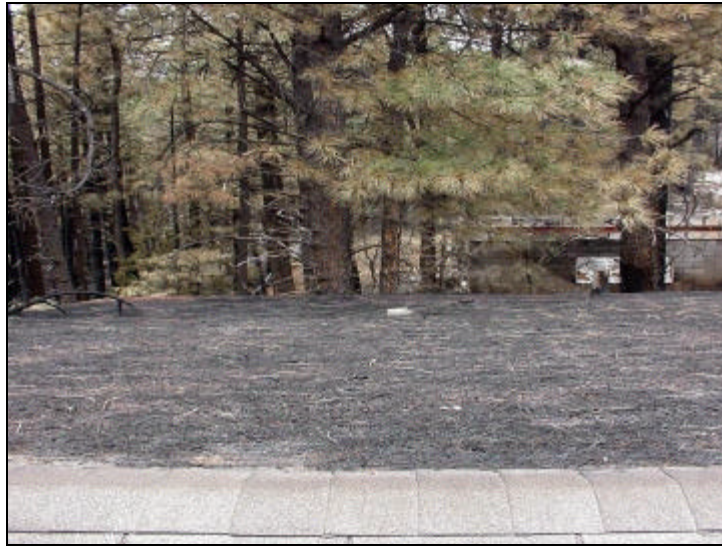
*Photo 8—The surrounding ponderosa pine canopy deposited pine needles on this roof. The roof surface fire burned the needles without igniting the roof. The roof covering types were “built-up” gravel and composition shingle. The house did not have gutters to accumulate needles, potentially ignite and thereby ignite the eave edge. Although the neighboring home was totally destroyed (in the background) the tree canopies did not burn. The roof pine needle fire likely ignited from firebrands generated by the burning home next door.*

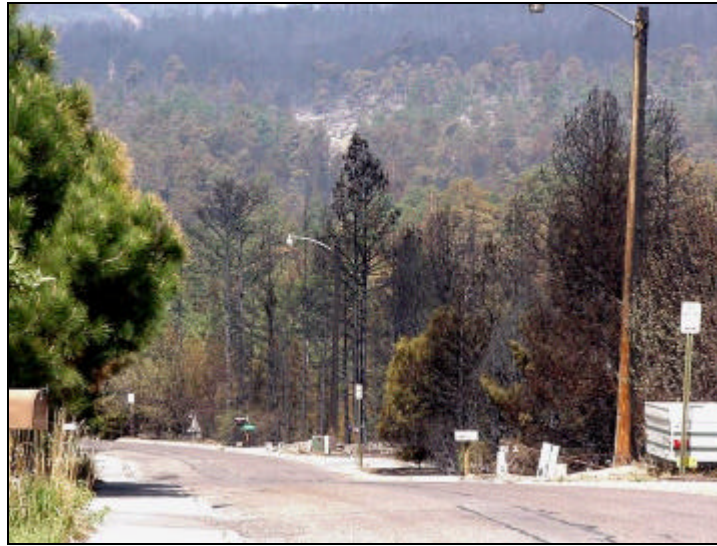
*Photo 10—This is a portion of the area within the yellow rectangle shown in the previous photo. The trees burned from the burning homes. The homes ignited from the low intensity surface fire and adjacent burning homes.*
